## Technical Report

## Reinforcement of the terracotta sculpture by geopolymer composite

Presented paper opens the possibility to use the geopolymer binder as fixing and joining material in restoration of the valuable historical objects. Special geopolymer composite was prepared to match the structure and color for reinforcement of the terracotta Baroque statue. The application in the cavity of the sculpture creates system of consolidating rims and ribs. The geopolymer technique was applied only on the unseen part of the statue, which ensured the stability and durability of the object without disrupting the aesthetics for the viewer. The exterior modulation and final restoration was carried out using classic technologies, specifically calcite-bonding agents, and is not the subject of this paper.

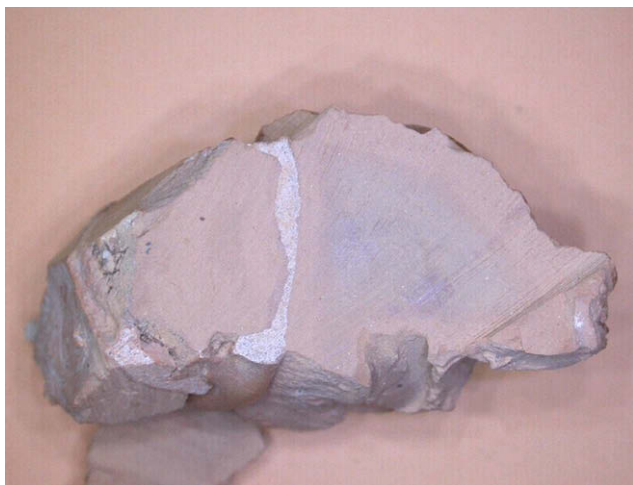
The prepared mass very well and easily penetrated the cracks and fissures of the ceramic body and joined them. Fig. 1 (below) depicts an example of a layer of the geopolymer composite binder joining two fragments of the original terracotta material. On this picture is possible to notice a marked difference in the shade of the cross-section as against the surface. The surface of the geopoly-

**Fig. 1.** The cross-section of the geopolymer joint between two ceramic–terracotta bodies.

mer mixture almost exactly corresponds with the color of the ceramic body which it joins, but the cross-section is considerably lighter. This can be explained by the movement of  $\text{Fe}^{3+}$  hydrated forms which are slowly carried by evaporating water and color the surface [7].

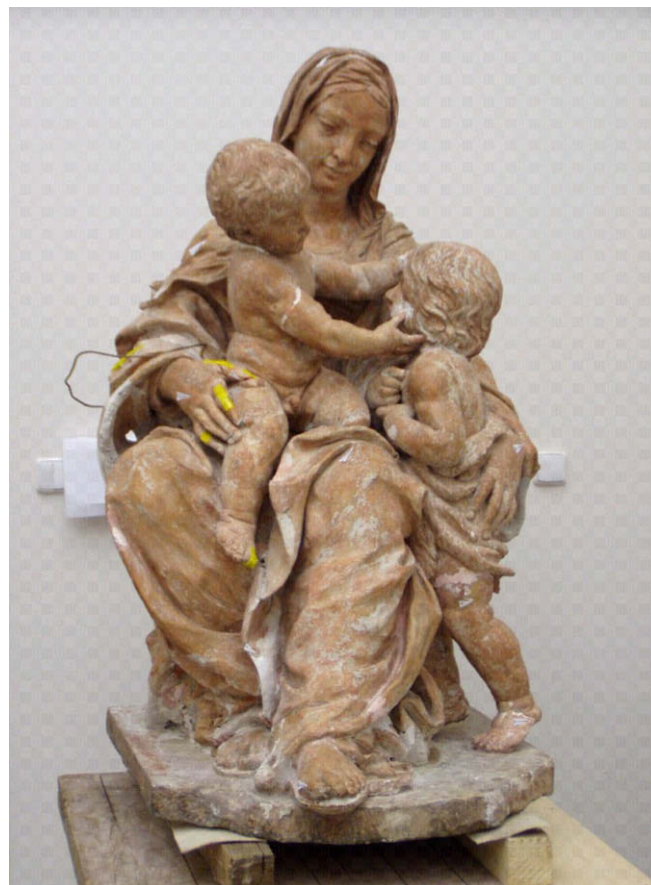
**Fig. 2.** The sculpture before the restoration – front view.

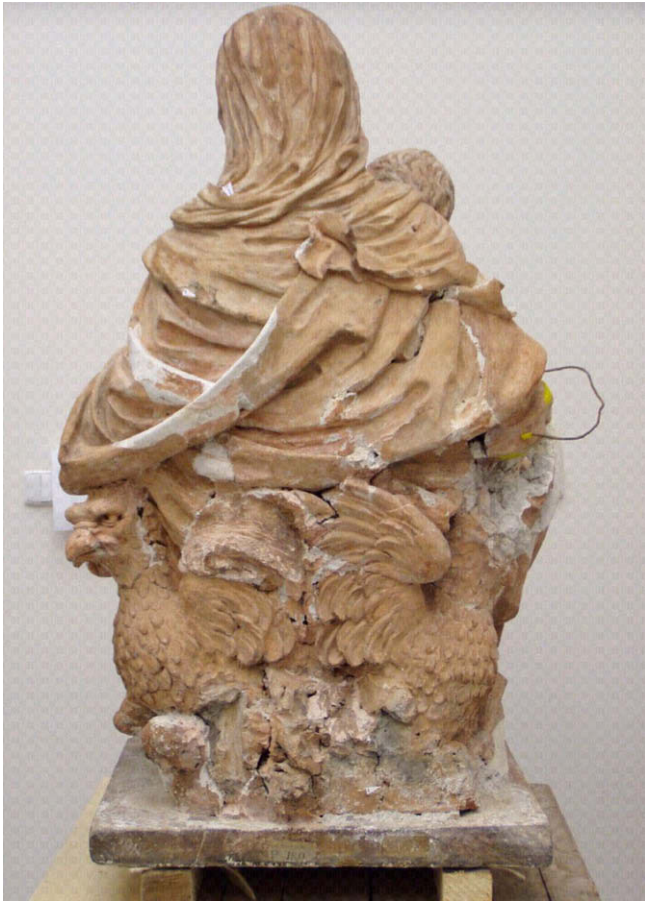
Fig. 3. The sculpture before the restoration – rear view.

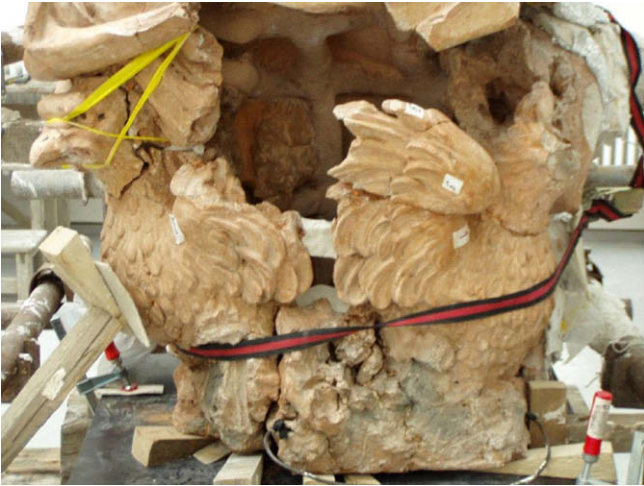
**Fig. 6.** View on the rear of the opened upright sculpture and preparation for the affixing of the bottom eagles.

Fig. 6 shows the upright sculpture while the affixation of the two bottom eagles is being prepared – two-thirds of the rims of the upper part, done before, are visible inside. The small white strip between the eagles' wings is the plasticine serving as a support for the geopolymer joining. The geopolymer composite does not react with the plasticine, which can thus be removed easily.

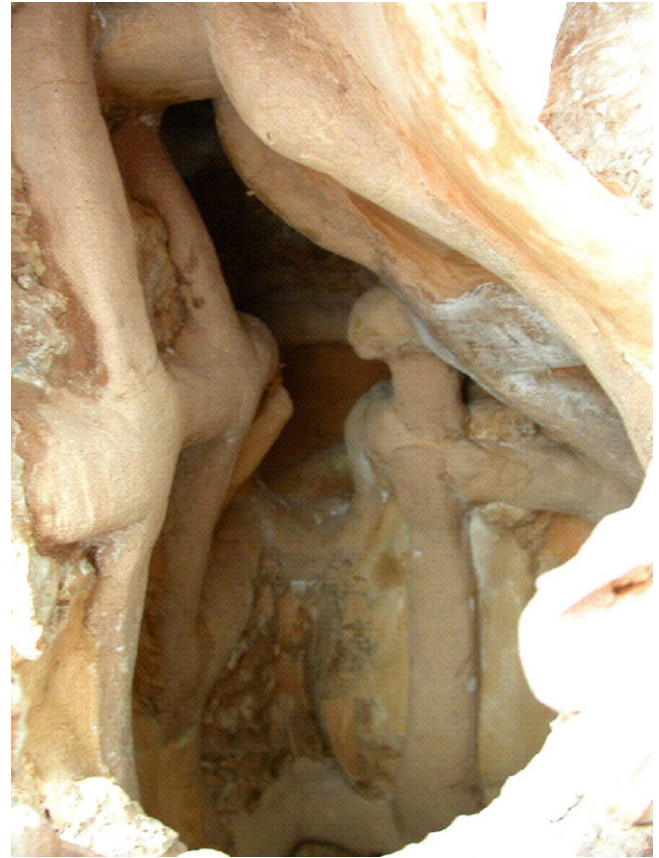
**Fig. 8.** Detailed view on the final stage of the geopolymer construction.

A final look at the inner geopolymer stabilizing construction is shown in Fig. 8. The picture was taken before the restoration of the outer modulation began, which was carried out using traditional techniques. The opening on the side of the sculpture, under the sitting Virgin's shoulder shows the final stage of the horizontal, circular rims and vertical ribs perfectly joining the ceramic body and thus ensuring the stability of the object. The upper part of the picture shows the joining of the geopolymer bands going up to the neck of the sculpture.

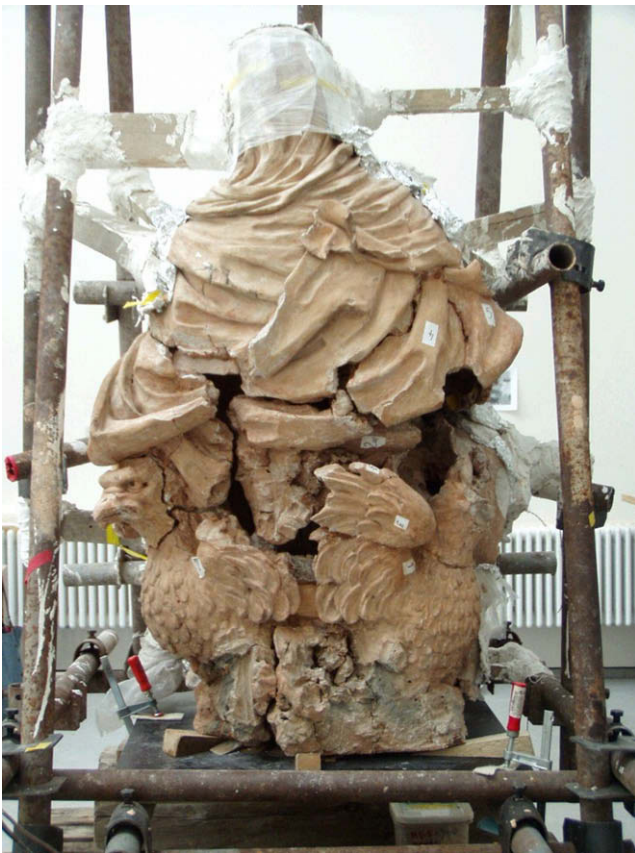
Fig. 7 shows the next step of restoration – the upright sculpture standing in a metal frame with the rear fragmented parts now attached and held in place by the geopolymer rims inside. This figure also depicts the heavy damage on the rear side and almost complete fragmentation, discovered after cleaning. It is also visible that several parts are missing, for instance the head of the right eagle. Also the broken bottom parts of the terracotta material, namely the "black core" inside the ceramic body, support the assumption that the firing temperature was low and unevenly distributed.

**Fig. 7.** View of the rear of the upright sculpture – the affixing of the fragments.
